MEMORANDUM FOR INFORMATION

29 January 1968

SUBJECT: Analysis of Vehicle Track on BX6842

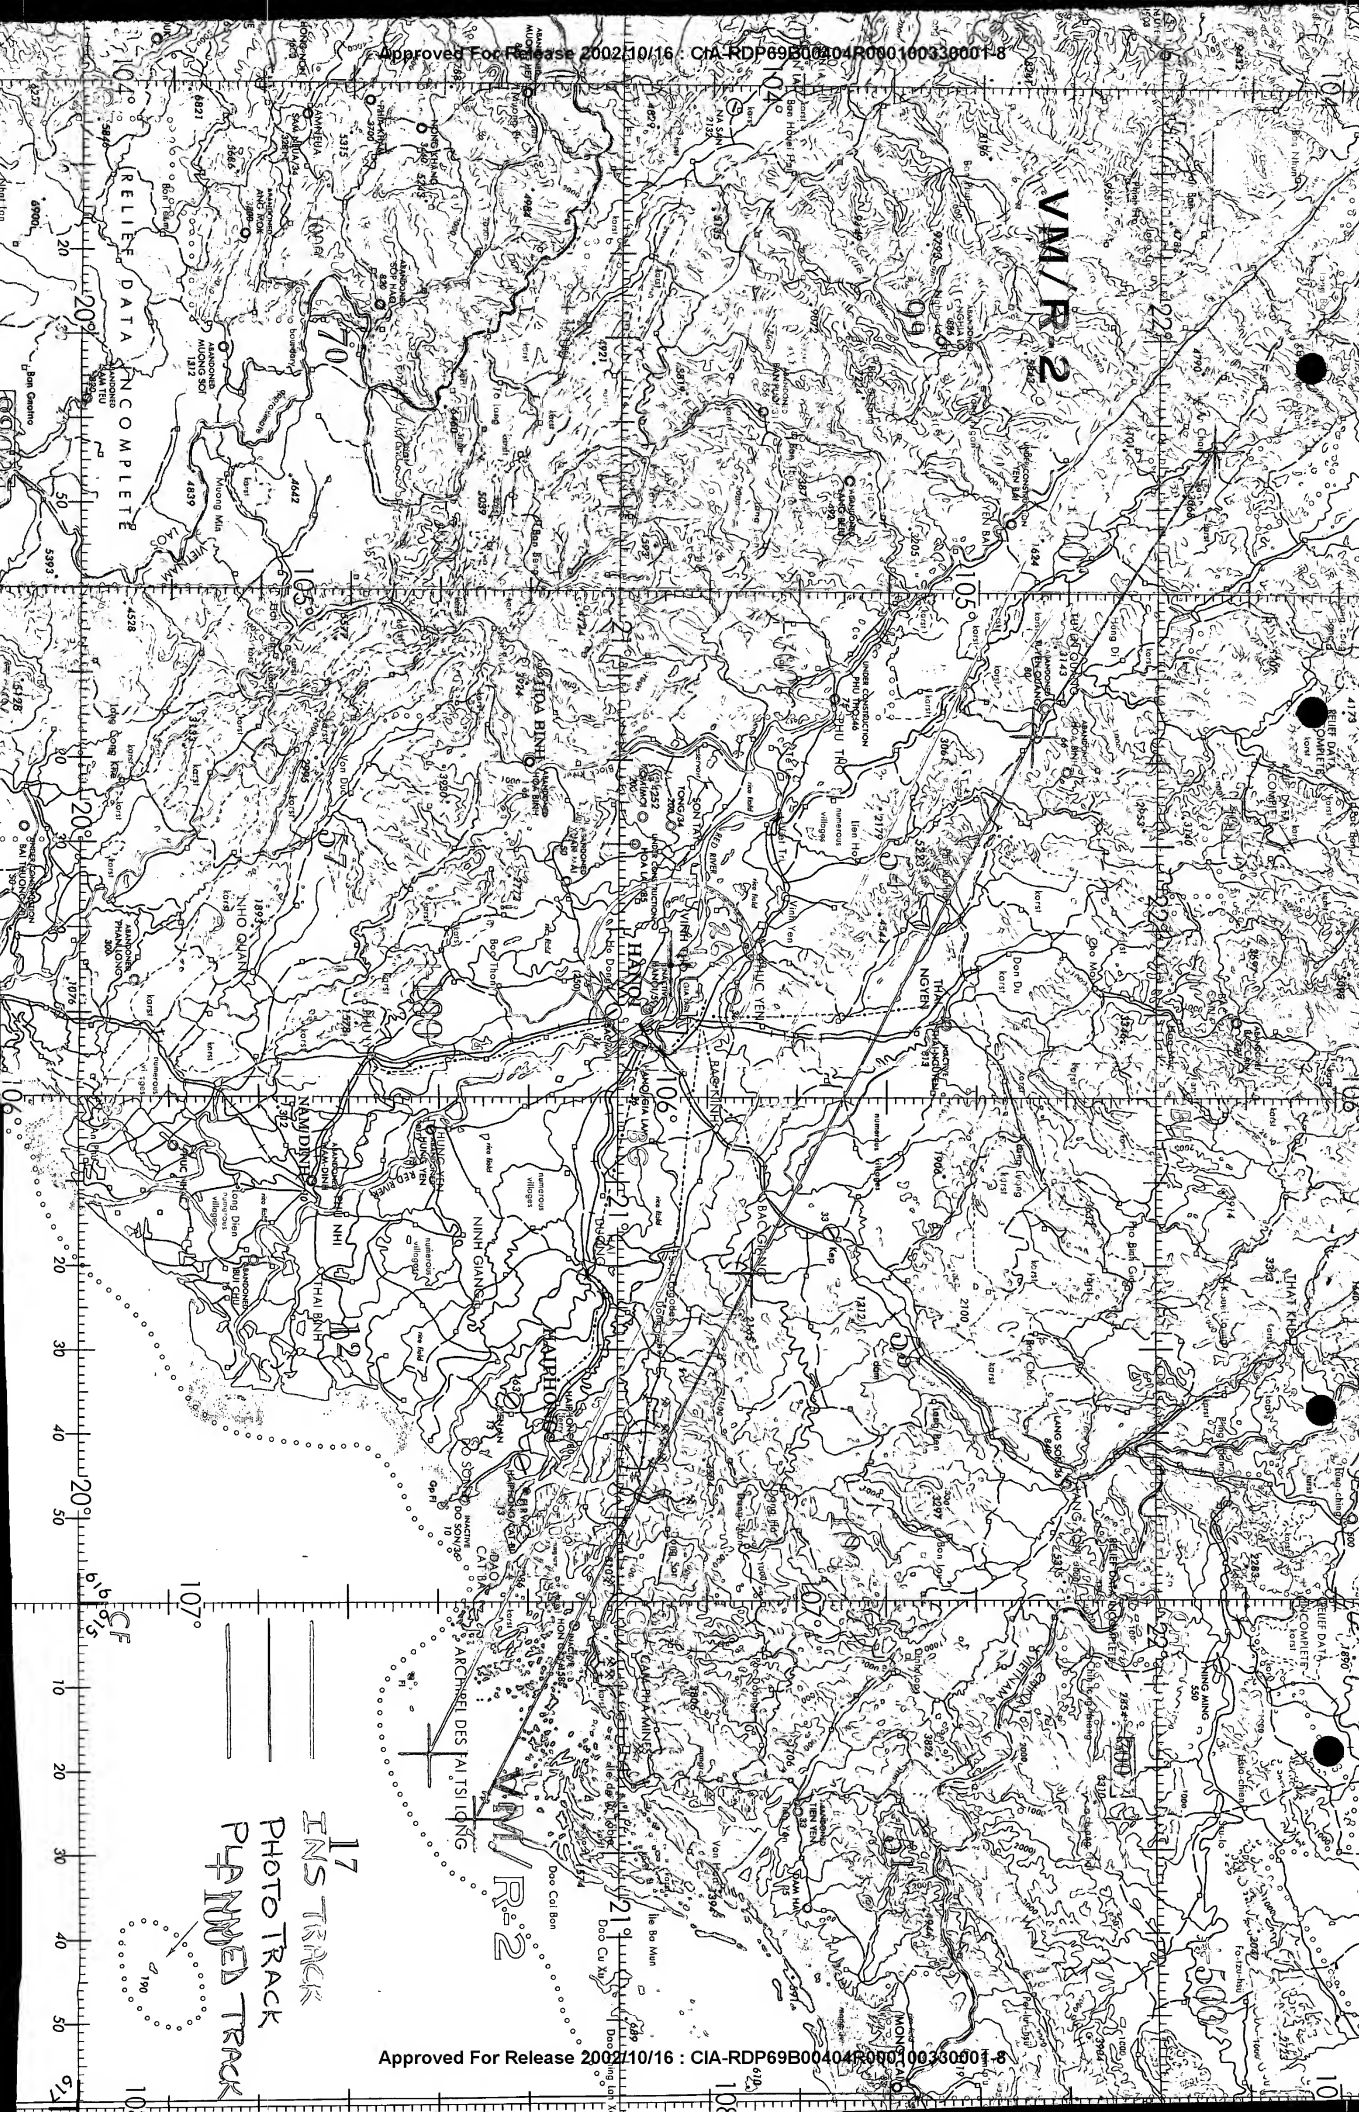
ATTACHMENT

1. Vehicle course on BLACK SHIELD Mission BX6842 was planned to pass 15NM abeam SAM Site No. 267 (black line on attached chart).
2. Reference to SC&DM data indicates INS tracked to the left of planned course and positioned the vehicle 17 1/2 NM abeam SAM Site No. 267 (red line on attached chart).

3. Actual vehicle track, as determined by reference to mission photography, indicated error in the INS and positioned the vehicle 24 NM abeam SAM Site No. 267 (blue line on attached chart). NPIC determined the vehicle passed 22.75 NM abeam Site No. 267 by plotting vehicle nadir position on a smaller scale chart from the exact frame taken abeam the site.

4. The non-standard INS position error; i. e., 5.5 to 6 NM error more than one hour before terminal error of 4.3 NM, is explained by equipment malfunction which was discovered as a result of Project Headquarters mission analysis and subsequent investigation. Malfunction of a temperature control amplifier allowed random rather than precise torquing of gyros within the INS and, most probably, caused the type error experienced.
